Manhole Inspection Summary

Manhole # S08CC2002MH

Location Address: **7062 Glengyle Ave**

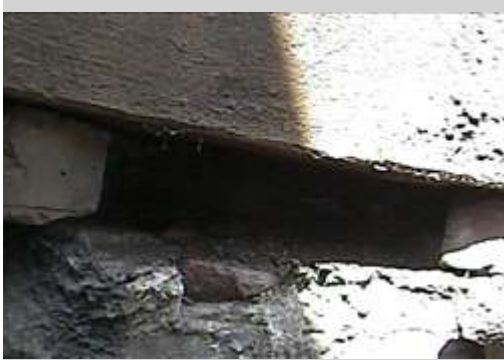
Defect

Frame Offset: **0** (in.) Condition: ☐ Sound ☐ Cracked ☒ **Leaks**

Condition: ☐ Sound ☐ Cracked ☐ Root Intrusion ☒ **Loose Brick** ☒ **Deteriorated**

Infiltration: ☐ None ☒ **Joint** ☐ Cracks ☐ Mortar ☐ Roots ☒ **Wall**

Frame leak, missing brick in adjustment.
Adjustment infiltration.

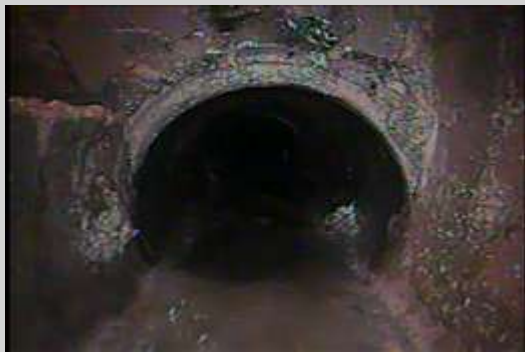
10 in. Circular Gravity Sewer Pipe Out @ 12 O'Clock

Infiltration: **Evidence** Pipe Seal Cond: **Unknown**

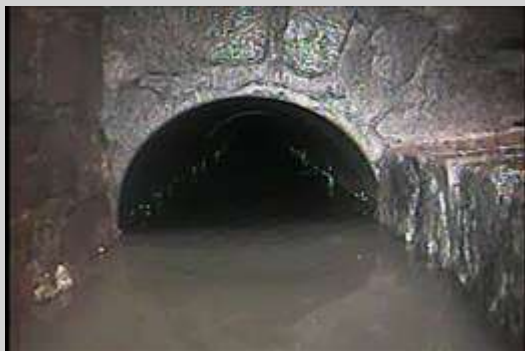
10 in. Circular Gravity Sewer Pipe In @ 6 O'Clock

Infiltration: **None** Pipe Seal Cond: **Unknown**
